“Flash Test Experience at Extended Temperatures”

...and other experiences of a test house

Integra Technologies LLC

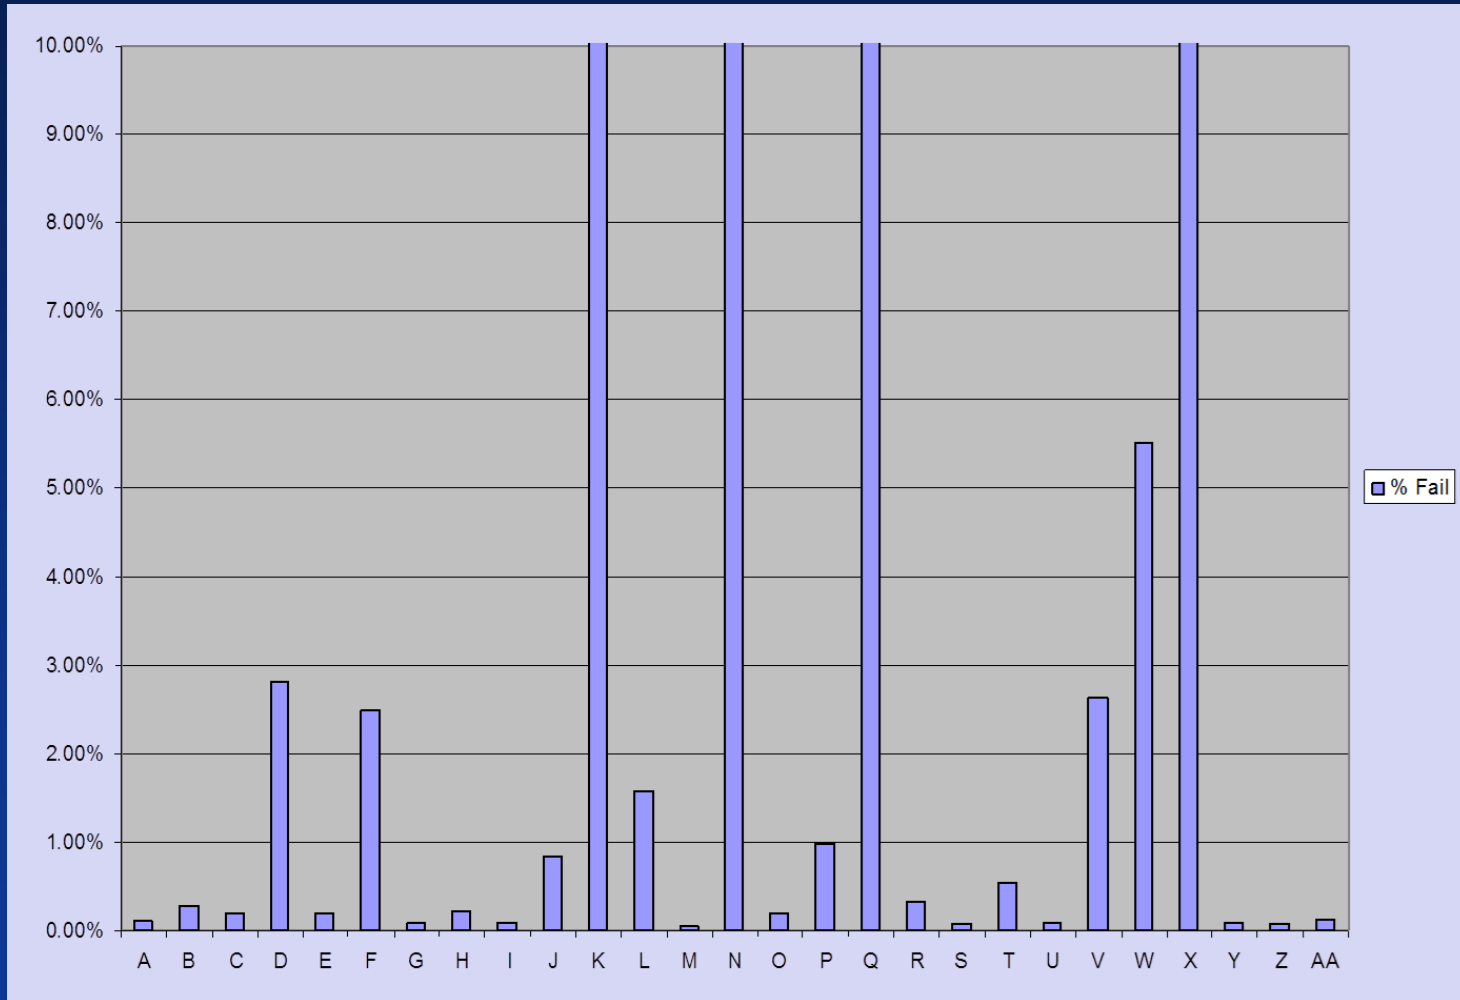
Supplier vs. Upscreen Yield

[data collected over past 15 years]

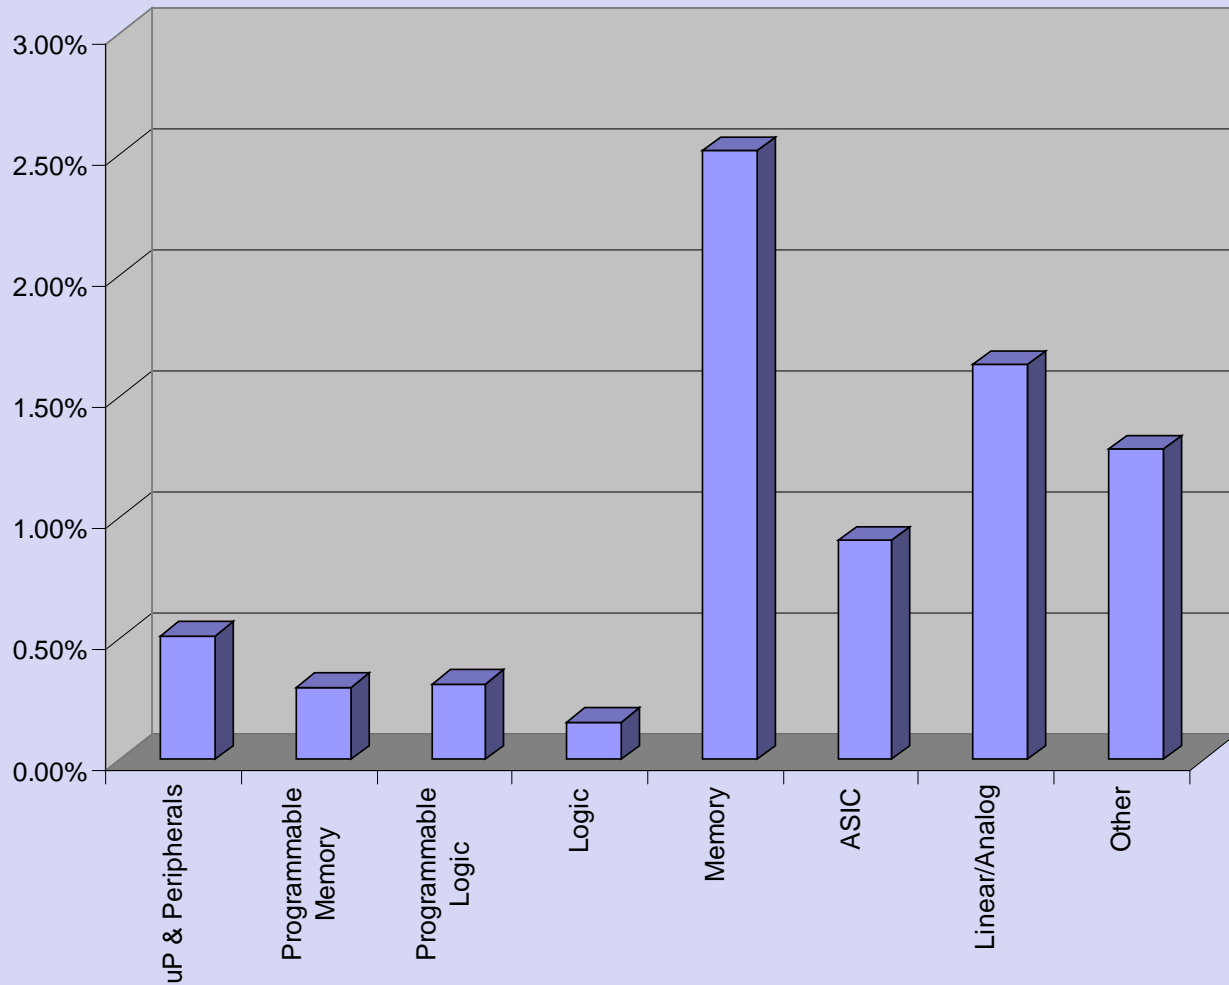
Upscreen Yield loss across device types

[data collected over past 15 years]

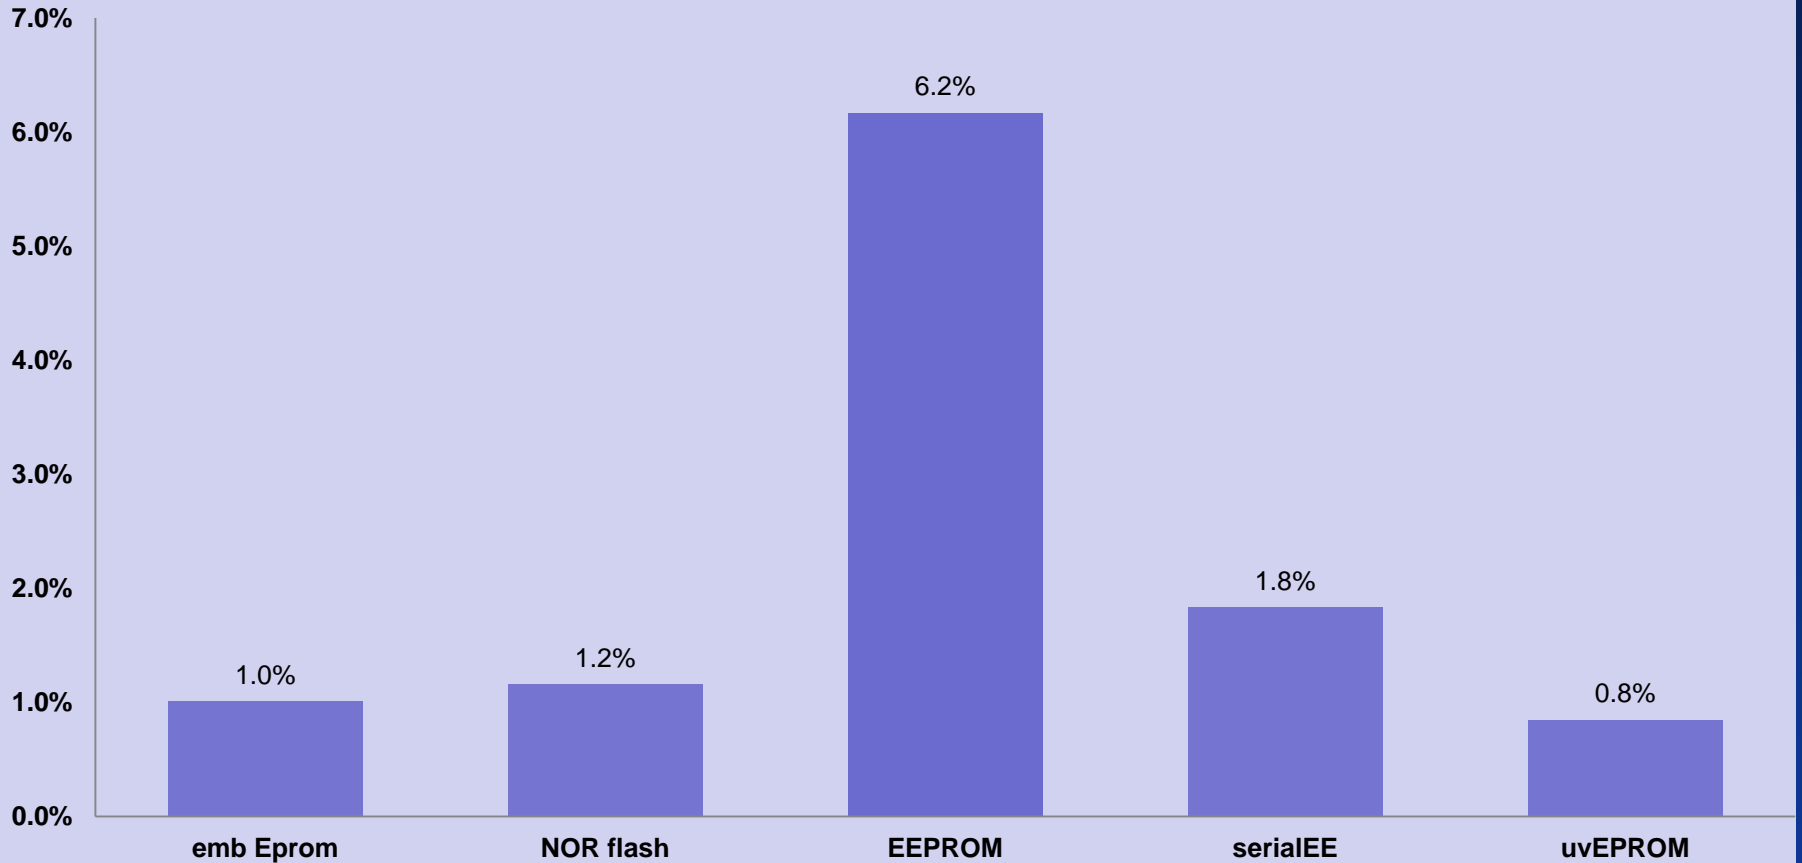
Flash Upscreen Lot Yield Avg

Avg Upscreen Yield Loss 5000+ lots since 1999

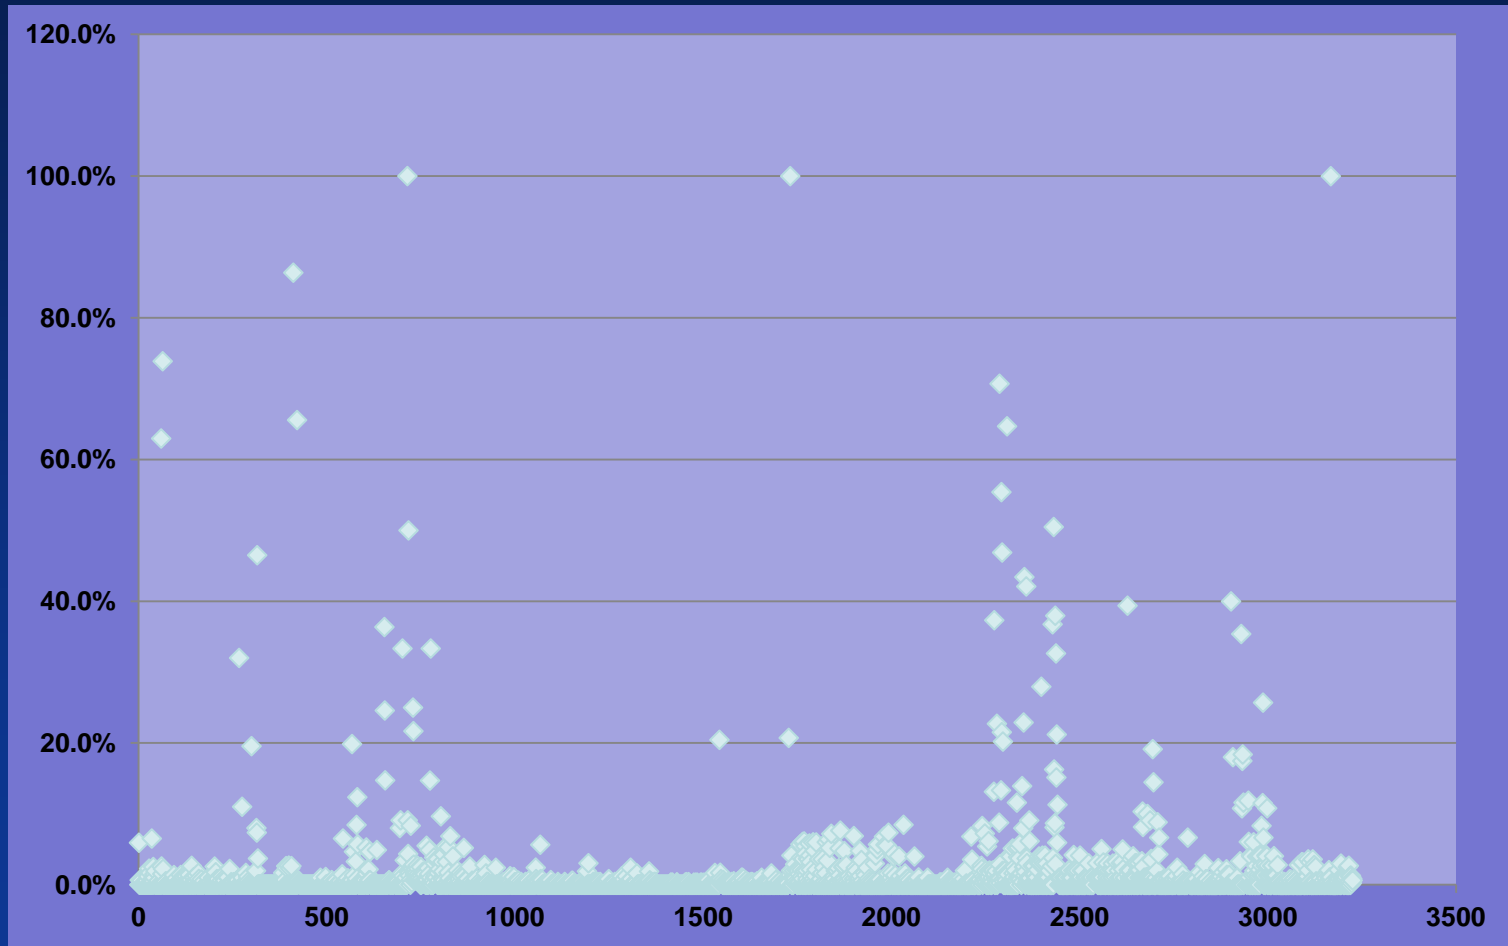
NOR FLASH lot Yield Scatterplot

[3000+ yield points for Upscreen typical -55C/125C]

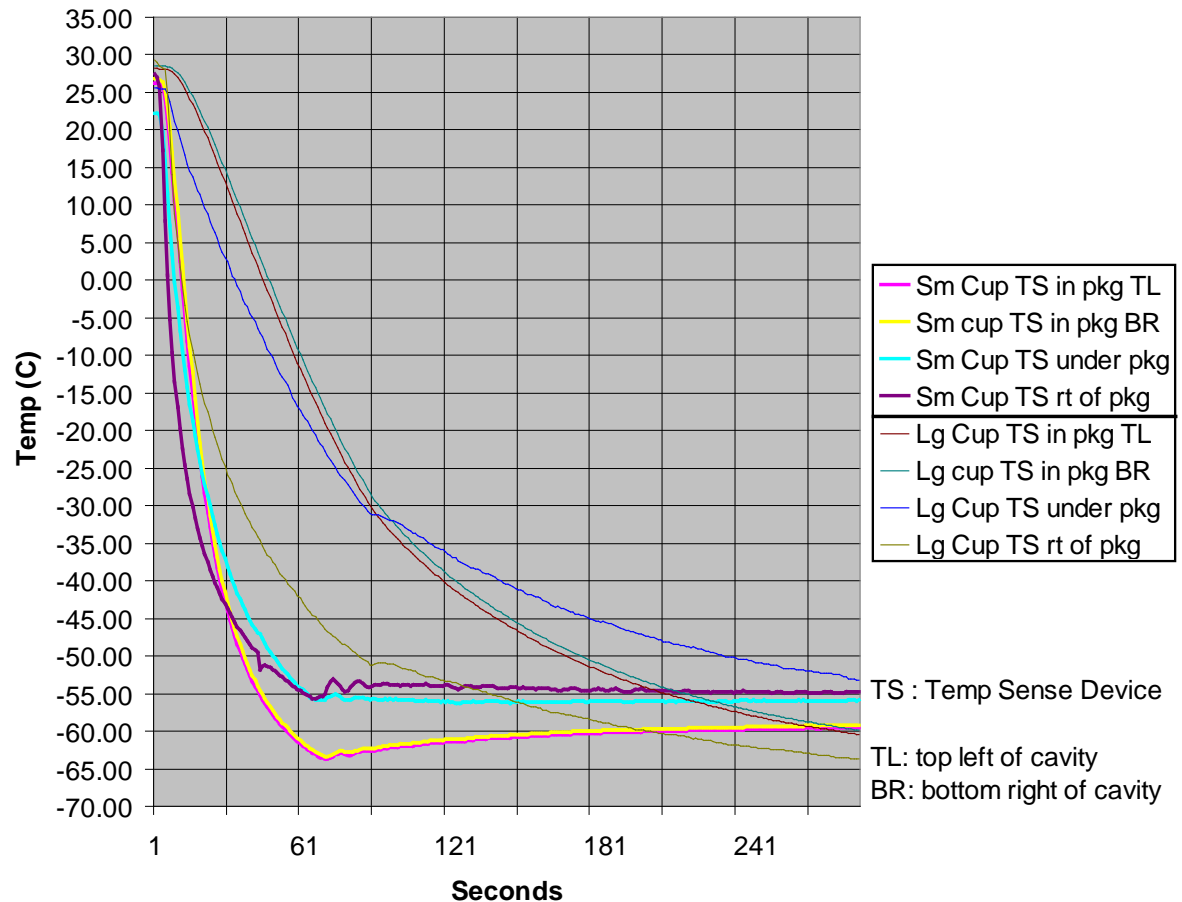
Thermal Cup & Soak Relationship

68 CQFP Temp Profile 25°C to -55°C
(Tempronix T/S system)

- Must run studies on unique packages
- Thermistor placement key
- 100% monitored during testing
- Automated temp control

- Most Probable Cause
 - See formentioned thermal soak chart

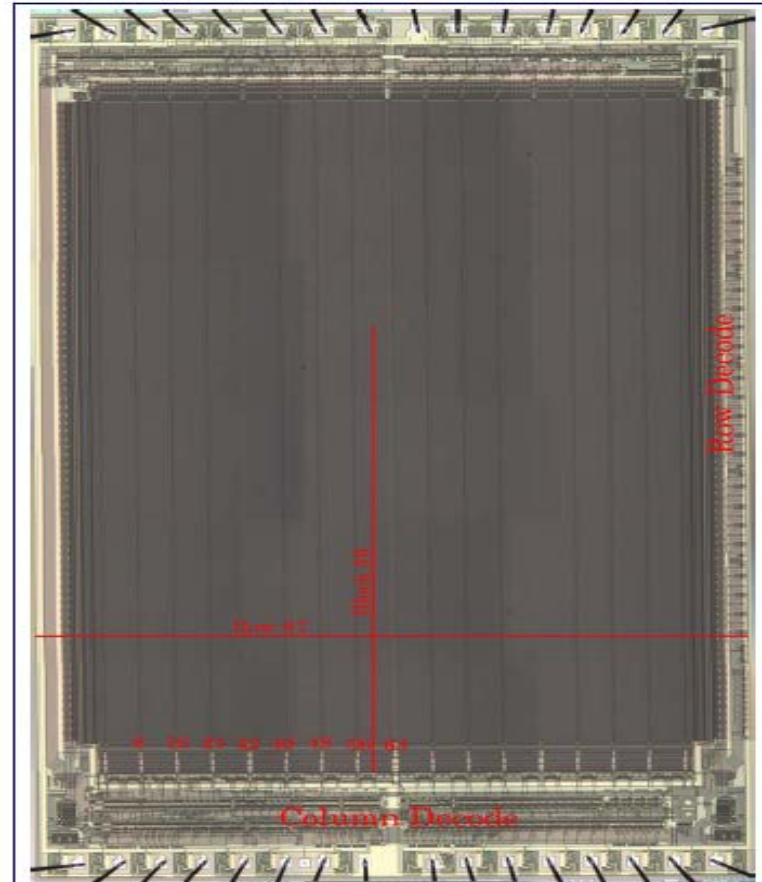
Overall Die showing the failing location:
Physical Row 87, Physical Block 59 (DQ7)

- Customer Return for -30C S/B Fail
 - 1 die on 128Kx32 MCM w/ 4 die total
 - Mapped out single bit Address & DQ
 - Determine Symptoms of fail
 - failed to hold '0' programmed state
 - Pass at -20C, Fail at -30C
 - Process De-layering to ID defect
 - Physical location isolated * NOT a Simple Matter *
 - Address scrambled
 - Logical to Physical translation
 - Package routing
 - Redundancy Caution !
 - Micro-probing with EBIC
 - insitu in SEM
 - provides added confidence in location
 - Great tool for this die because of near-Zero ICCq

- Deprocessing by Analytical Solutions Inc
 - Defect identified in the Tunnel OX
 - Wafer Fab process defect
 - resulted in weak cell for tunneling electrons
 - reduced charge with temperature threshold

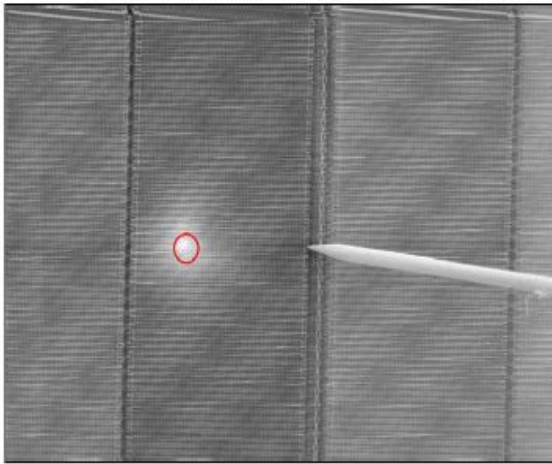
Figure 5

Caption: Further close-up SEM view showing microprobing of the failing row and EBIC signal (red circle) at the failing bit.

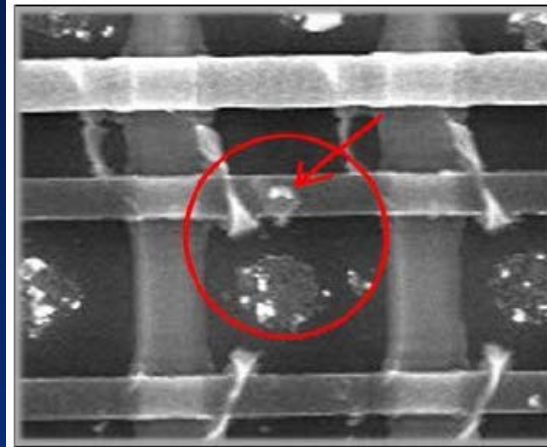
Figure 9

Caption: Detailed SEM view showing the failure site identified by EBIC; note an apparent defect (arrow) was observed within the poly directly over the failing EEPROM bit.

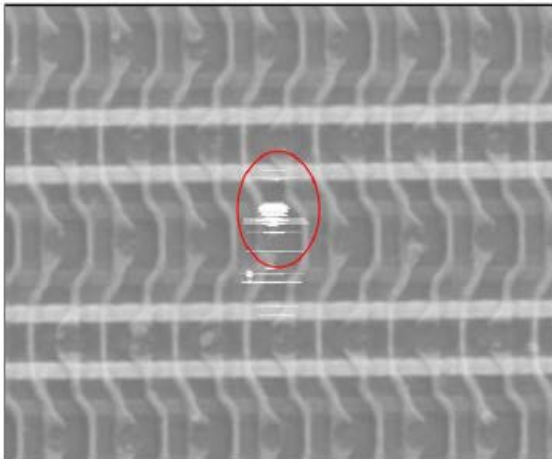
Figure 6

Caption: Detailed view showing EBIC signal at the failing cell location (red circle).

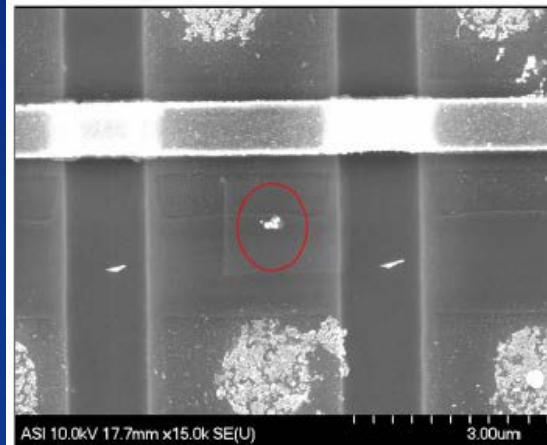
Figure 10

Caption: Close-up SEM view showing the failing bit following removal of the polysilicon; note the particle remained in the tunnel oxide.

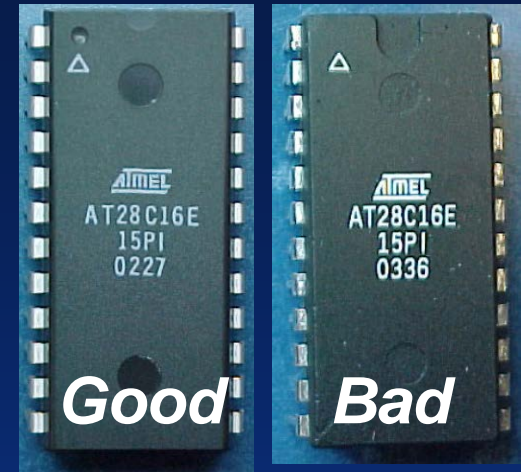
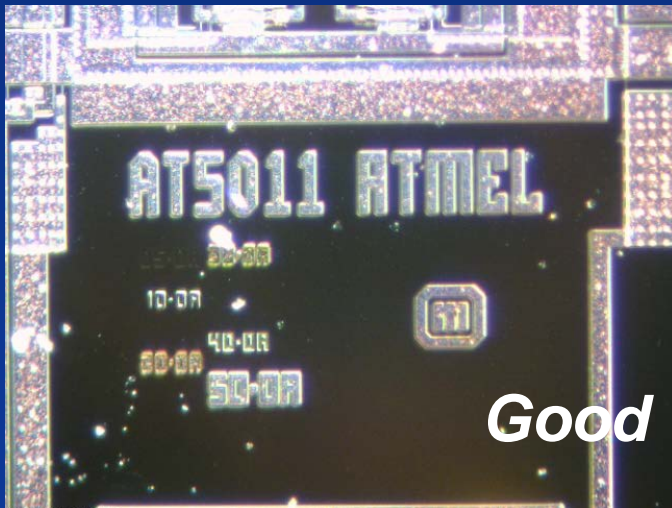
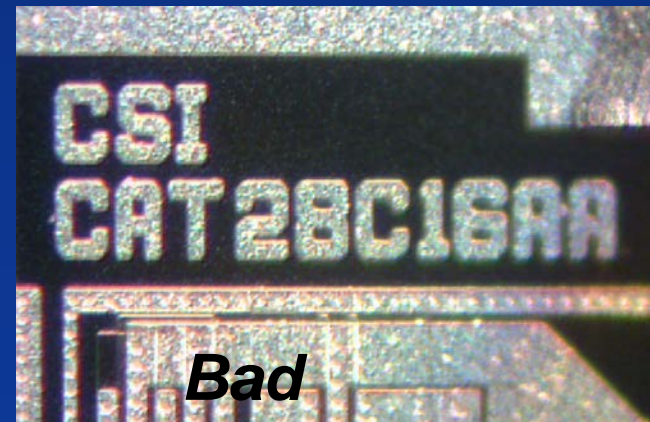
Counterfeit example

- Visual Inspection (no clear issues)
- Marking testing passed
- Die inspection found the correct generic but wrong manufacturer
 - Catalyst acquired by On Semi
- Testing Results
 - All units passed functionally
 - Only failure was one parameter
 - Slower TWC (write cycle) then the Atmel data sheet
