Challenges in Preparing SSDs for Qualification Testing

Vishal Devadiya

R&D Application Engineer Advantest America Inc.

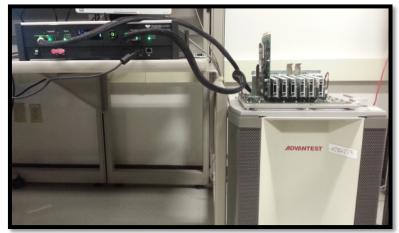
- Perform analysis on available logs from host as well as from drive
- Use protocol analyzer, capture bus trace and perform analysis

PCIe Analyzer on Engineering Tester

Challenges to Capture Trace Using Protocol Analyzer

- Issue may not occur on fixed slot# on tester
- Need to connect multiple protocol analyzers (PA)
- PA interposer may changes properties of the signal
- Cannot stop the on-going test on other DUTs and debug
- Have to reproduce the issue
- Cannot connect PA, if the test is running under thermal environment

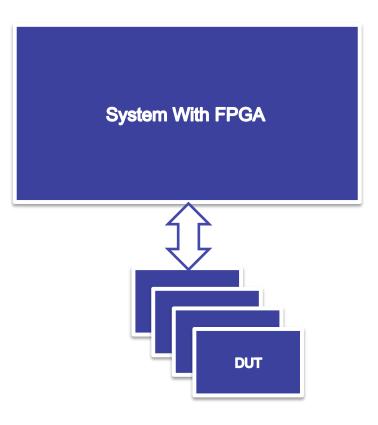
Solution: Traffic Capture Tool

- Transaction Layer Packet capture
- Link raining & Status State Machine (LTSSM) capture
- Submission & Completion queue information
- Command log dump

- Run test on all slots at the same time, and capture required information to debug the issue
- Capture traffic log at the time of the failure, and not to reproduce the issue
- Flexibility in logic design add/remove logic to capture more information if required
